**DATE:** September 9, 2016

**FROM:** Gregory A. Vance, Inspections Administrator

**TO:** Investigator W. O'Neal, Wake County Sheriff's Office

**RE:** Investigation of Wiring at Heritage Point Community Pool

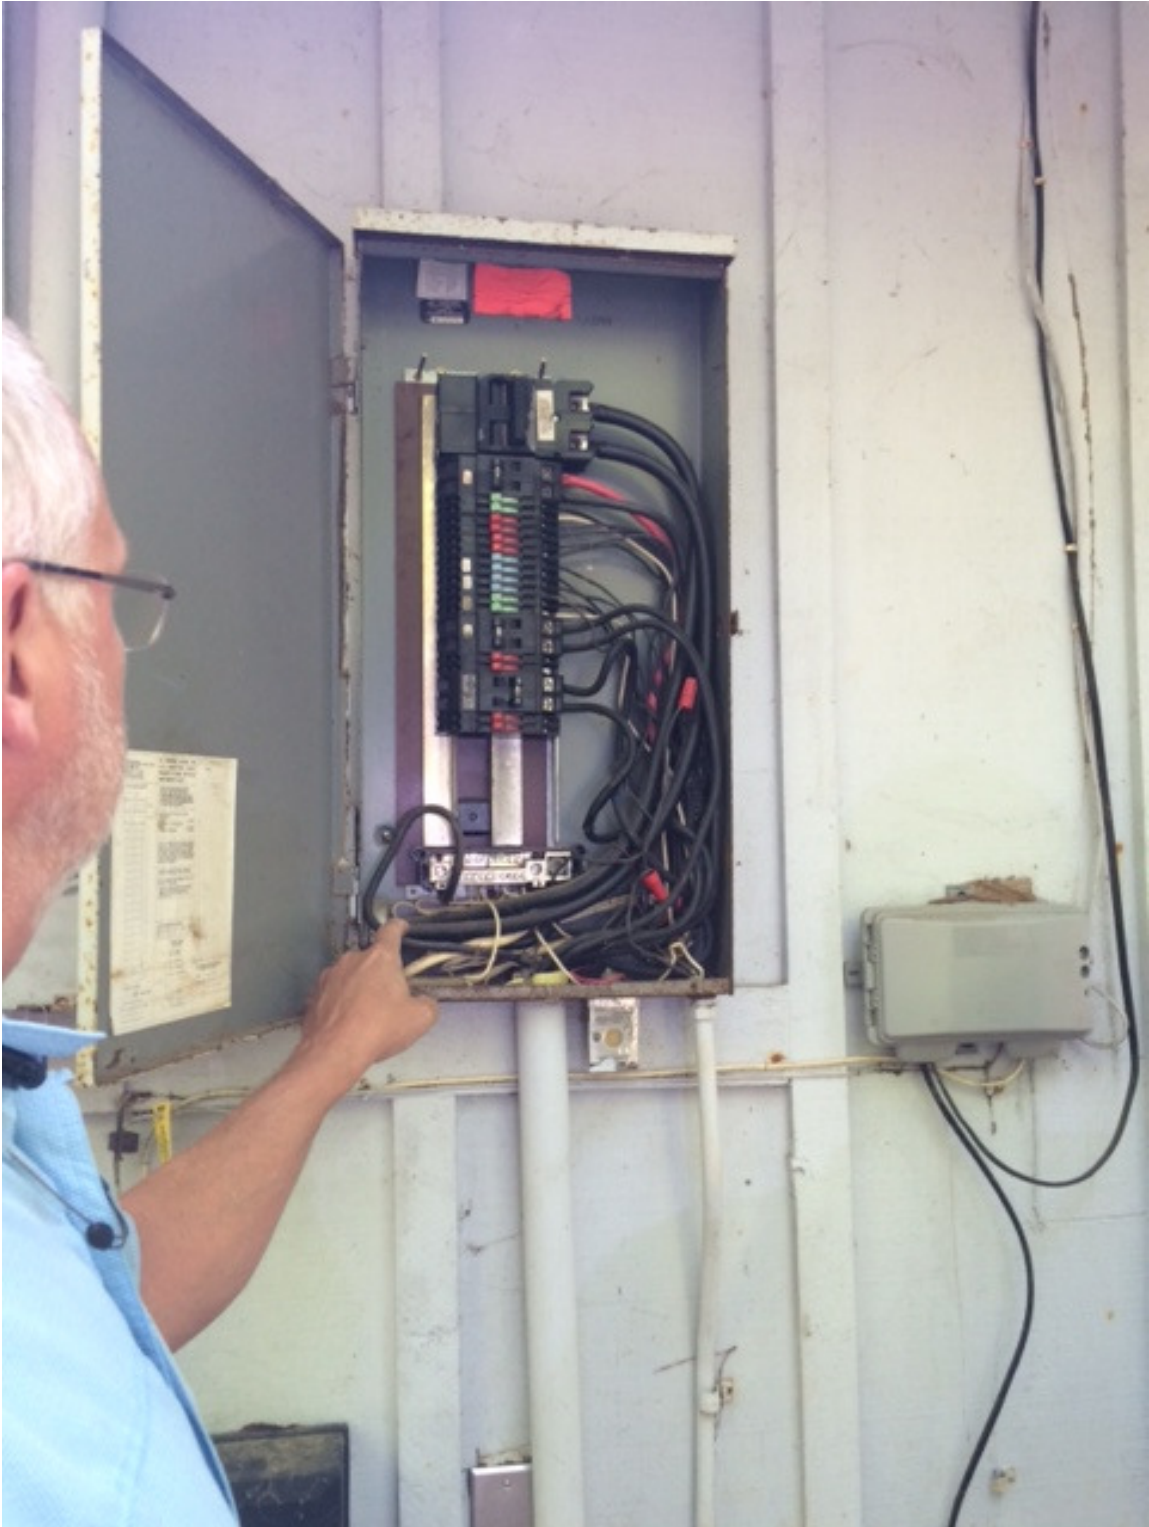
The investigation found that the pool pump was fed underground from a house panel (see image 1) located on the exterior of the community club house. The electrical feeder consisted of three conductors (two ungrounded and one grounded), typical of electrical practices of the period and compliant with NEC 250-61(a). Overcurrent at the panel was a 60 ampere breaker and conductors were #4 aluminum. The insulation type could not be identified. The electrical feeder to the pump had been repaired (see image 2) in 2011 per the representative of Aquatic Management Group. Approximately 5 feet from the pool house, the old electrical feed had been relocated above ground, spliced to new type URD #2 aluminum conductors and the new conductors ran to the existing fused disconnect in the pool house. The County has no knowledge of who performed this work. Such work requires an electrical permit per N.C.G.S. 153A-357.

Image 1. House panel.

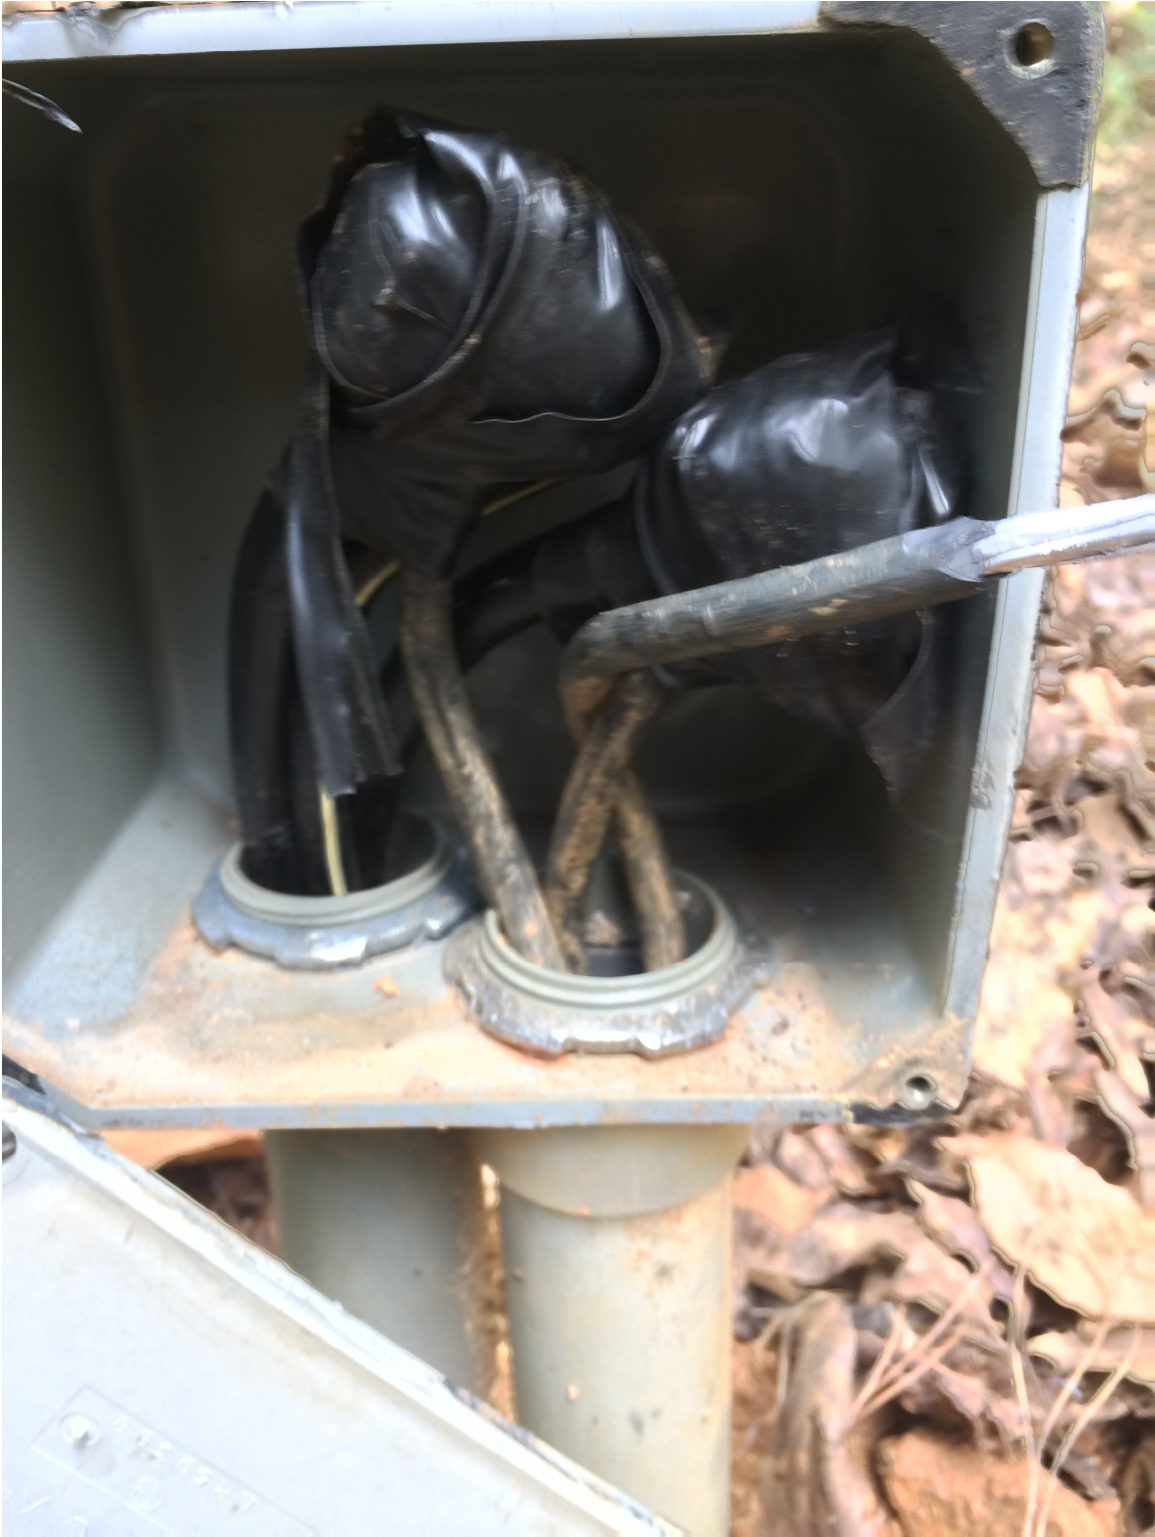
Representatives of Future Connections Electrical tested the grounded conductor of the electrical feeder to the pump for continuity between the house panel and the pool house disconnect and found that the conductor was open (broken/could not conduct electricity). They then tested to the junction at the repair and the conductor was still open indicating a break in the original ungrounded conductor installed in 1979.

Image 2. Repair of electrical feeder.

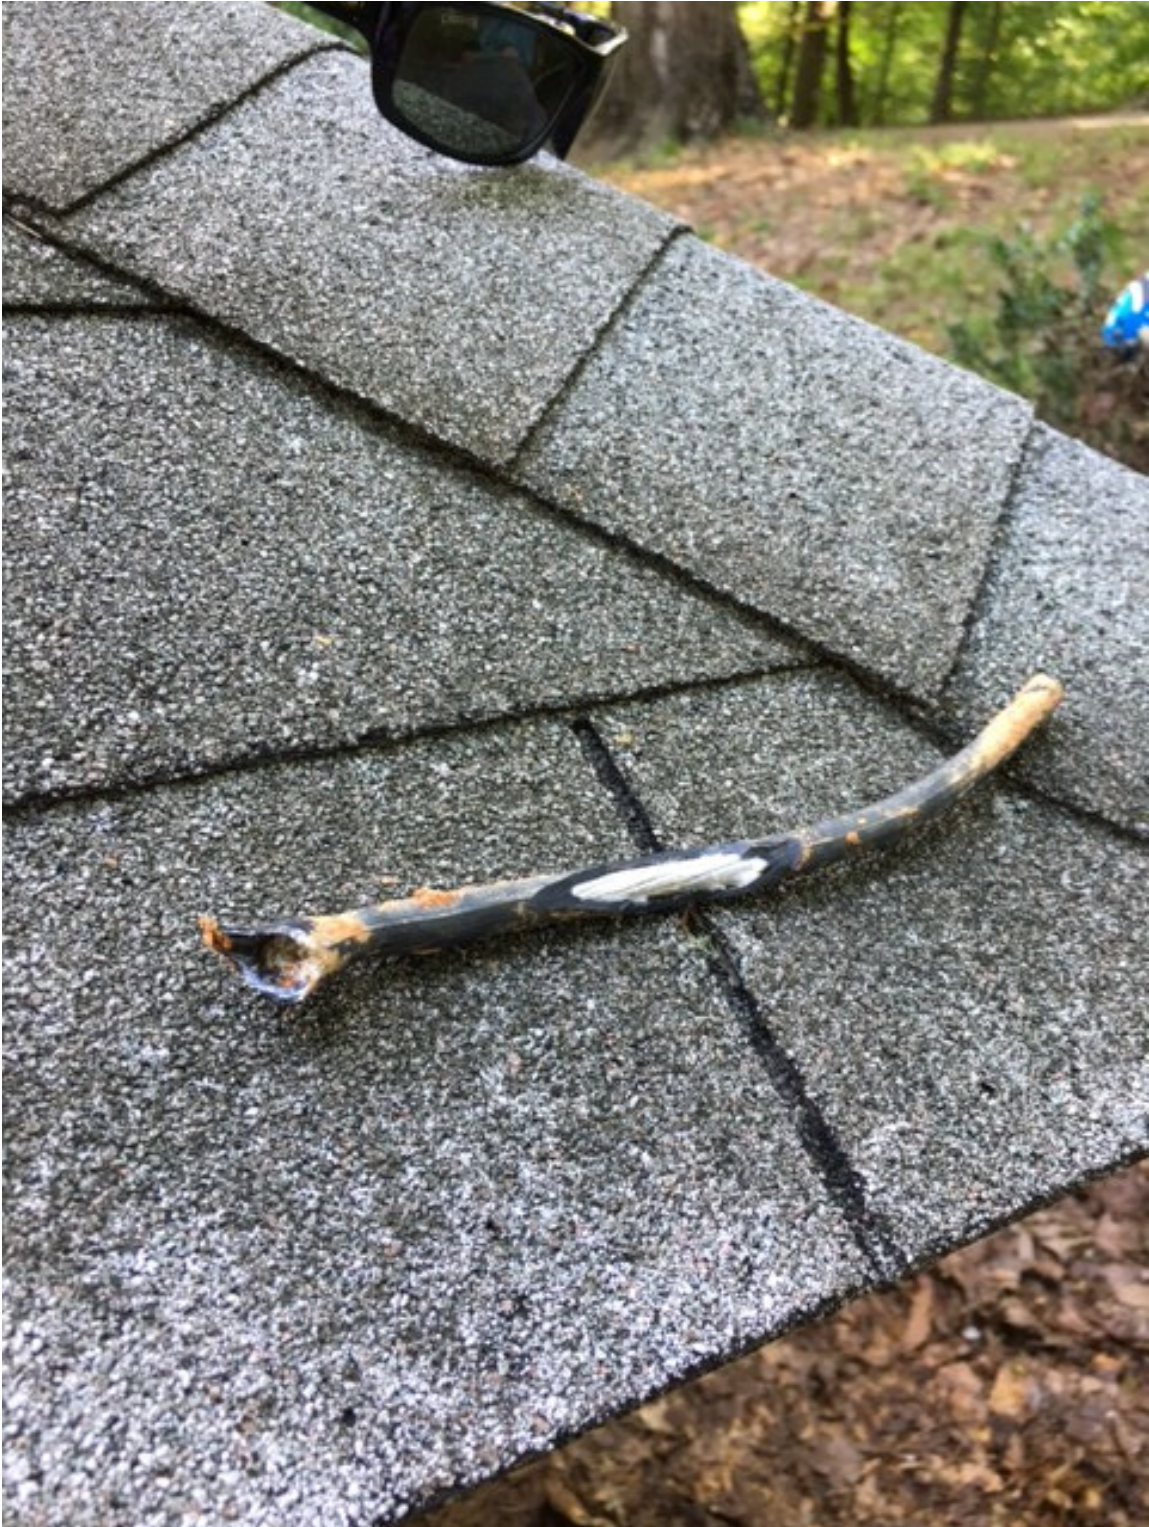
Representatives of Future Connections Electrical located and excavated the break in the conductor (see image 3). The conductor was fully corroded and unable to conduct electricity. The electrical feeder terminated in a 60 ampere fusible disconnect (see image 4) inside the pool house. The disconnect was fused as 40 amperes on one leg and 60 amperes on the other leg. The disconnect appeared to be in proper working order and the overcurrent was set to within acceptable limits for code compliance.

It is my conclusion that, the pool pump motor failed and phase A faulted to ground. The underground feeder had an open ungrounded (neutral) conductor. The only load on this feeder is the 230 volt pump, therefore there was no indication that the ungrounded conductor had failed. Article 250-61(a) of the 1978 NEC states "A grounded circuit conductor shall be permitted to ground noncurrent-carrying metal parts of equipment . . . on the supply side of main disconnecting means of separate buildings. . ." This is intended to provide an effective ground-fault current path. Article 100 of the 2014 NEC defines effective ground-fault current path as ". . . a low-impedance circuit facilitating the operation of the overcurrent device . . ." When the phase A faulted to ground, the intended path for fault current was the grounded (neutral) conductor. Since this conductor was open (broken) it could not conduct the

necessary current to cause the overcurrent device (breaker) to open (trip). The fault current then followed the only path available to it, the pool water, creating a voltage gradient across the pool and pool equipment.

Image 3. Failed conductor.

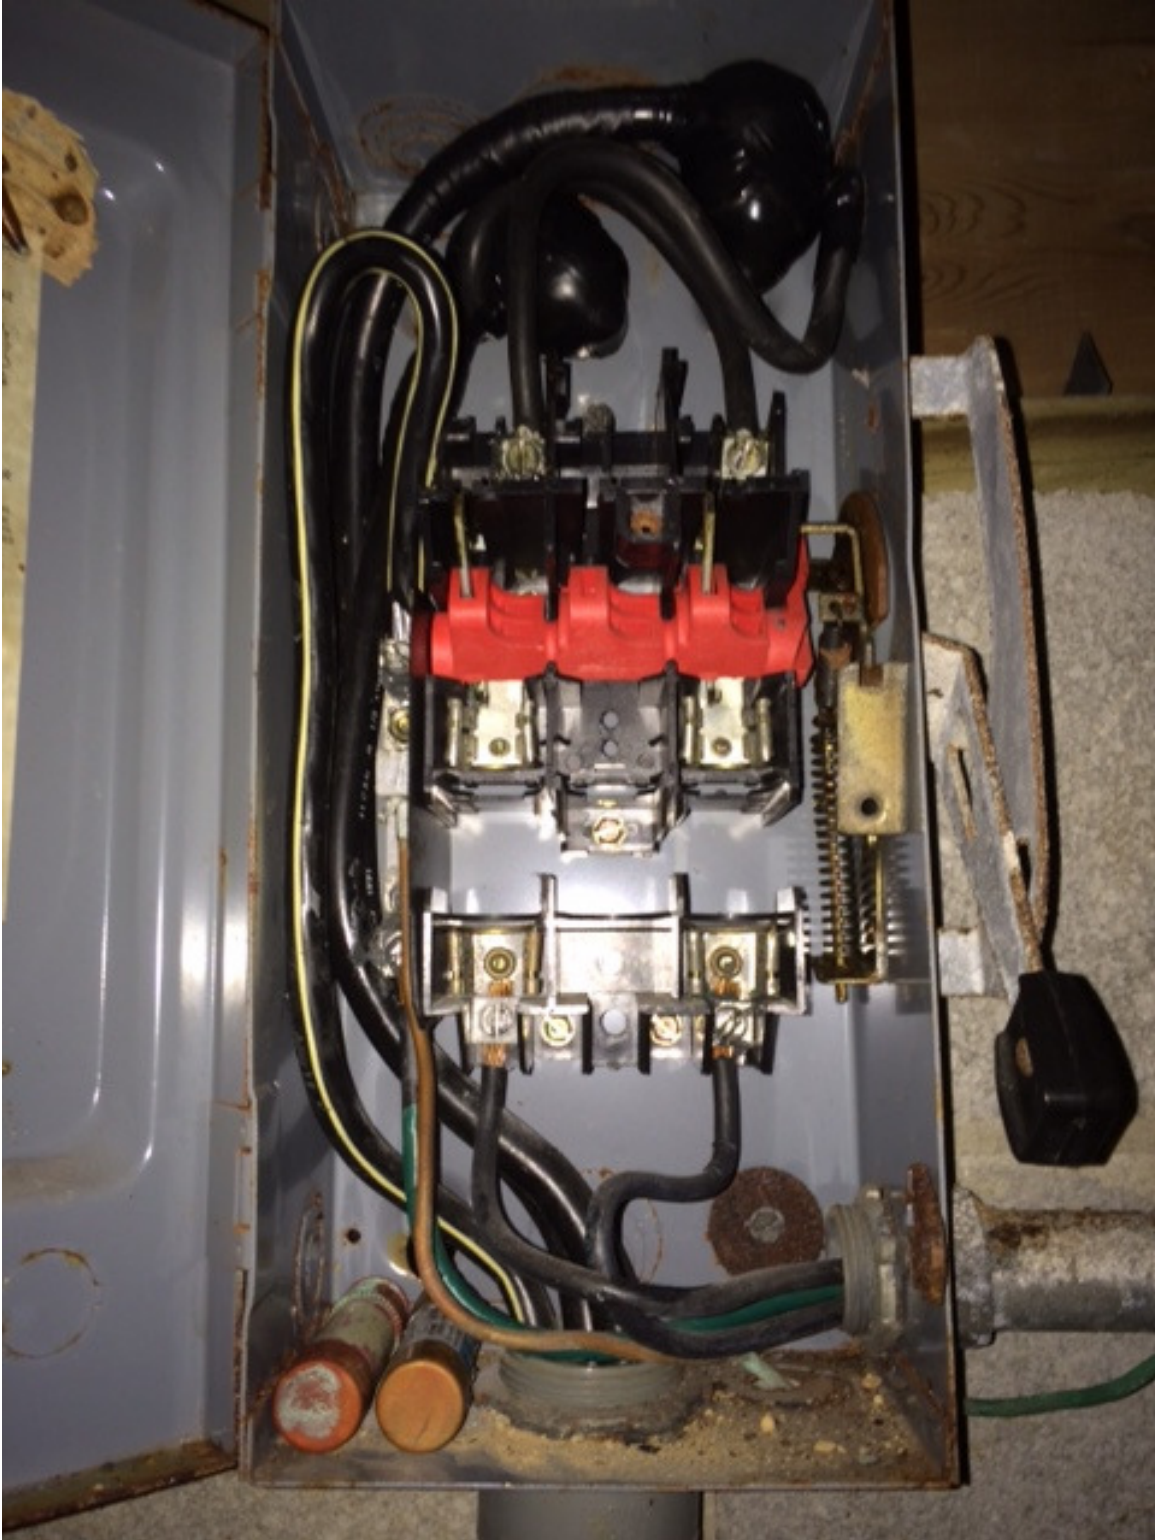
Image 4. Fusible disconnect.

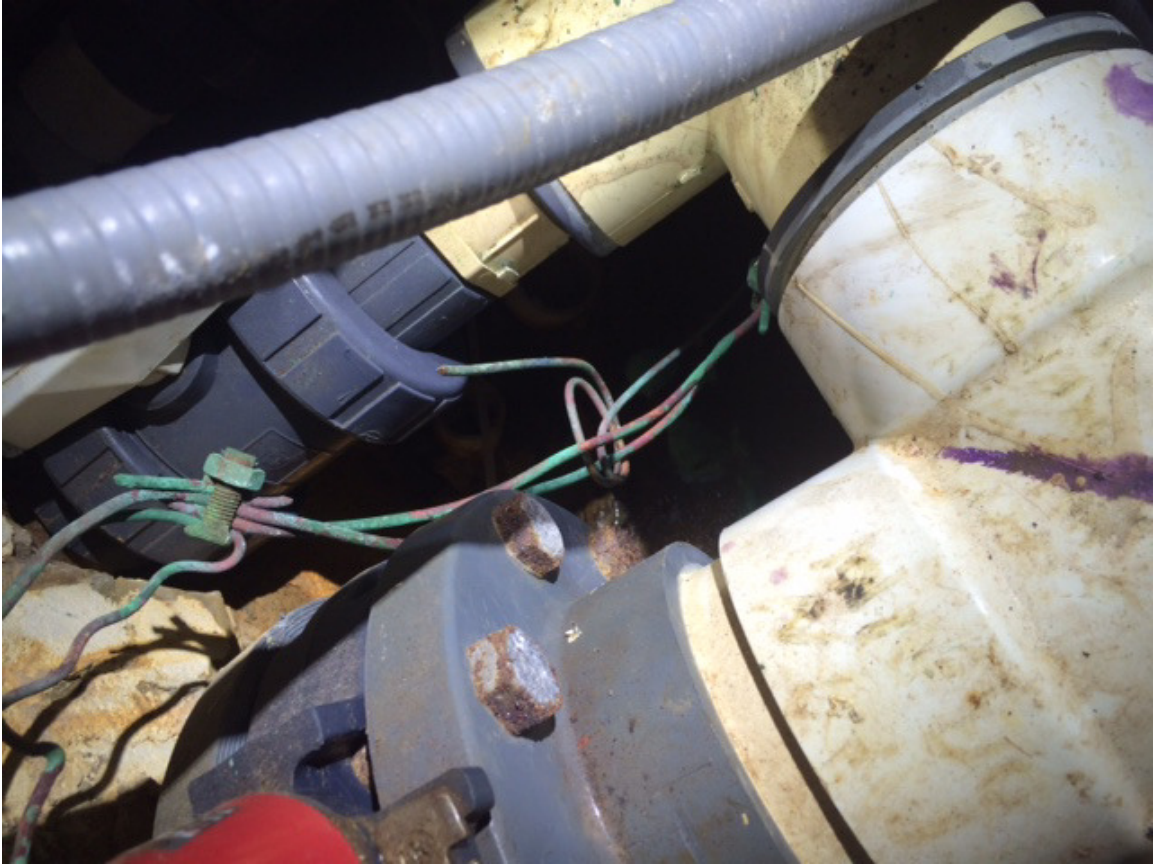
Representatives of Future Connections Electrical tested the ungrounded conductors feeding the motor at the motor starter and found that phase A had faulted to ground. The motor bonding wire was terminated properly at the motor but had been cut and loosely wrapped around the equipment bonding wires (see image 5). This alteration was located behind piping concealed from normal view. This is not compliant with NEC 680.22 that required all metal parts of the pool structure, metal fittings, metal piping and fixed metal parts within five feet of the inside walls of the pool, and all electric equipment associated with the pool water circulating system, including pump motors to be bonded together. However, it was discovered that an alternate electrical path provided a connection to the motor bonding wire and it was determined that the cut wire noted above did not contribute to the electrical charge in the pool. Furthermore, the function of the pool bonding system, in accordance with NEC 680.22, could not be verified at the time of the investigation.

Image 5. Cut motor bonding wire.
